Arboricultural Report:

*Evaluation of Trees at Templemere Estate, Oatlands
Drive, Weybridge, Surrey*

APA/AP/2013/115

27th April 2013

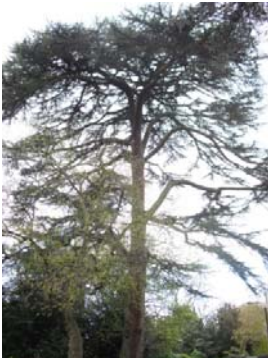
T1

These trees are all healthy, mature Cedars which have been well maintained and which exhibit no features of particular concern from a health and safety perspective.

- 6.1 No works are recommended at the present time in relation to Cedars T1, T2, T3, T4 and T5 or Douglas Fir T6.
- 6.2 With regard to Cedar T7, removal of this tree is recommended on grounds of safety. The tree has a cavity at the base, decay in the main stem and Woodpecker holes with associated decay in the subsidiary stem. Furthermore, a report by Mr P Warrener of Branch Management on 1st March 2010 (following a climbing inspection) noted that there is decay at the top of the tree (where it was topped following storm damage). Large lateral branches arise from the main stem adjacent to the decayed area and, were the tree to be retained, there would be an increasing risk of these large branches failing as the decay progresses. The main stem of the tree is leaning mildly towards the adjacent dwellings (to the south) and failure would have the potential to cause substantial damage/injury. Overall, this tree is considered to be unacceptably hazardous and it is not felt that any reasonable pruning works could be employed to satisfactorily address this issue.

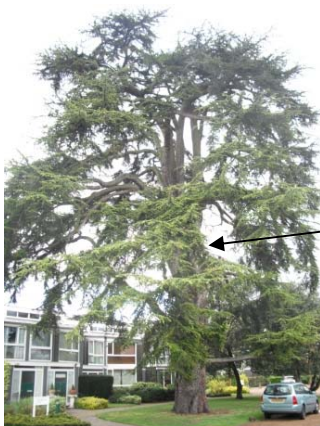
This mature Cedar is in good health, but has a higher failure potential than the above trees owing to the fact that the main stem divides into multiple stems at a height of approximately 9m. There is included bark between the stems, which can predispose trees to failure if they are subjected to heavy wind loadings. It is understood that a large stem on the eastern side of the tree failed approximately two and a half years ago after a climbing inspection had revealed some cracking. A limb on the western side of the crown has been cabled. Although the cable is of a specification not now recommended (bolts have been inserted into the tree rather than non-invasive slings being used), the cable is under tension and appears from the ground to be in good condition.

Main stem divides into multiple stems at height of 9m approx. Tree has relatively high failure potential

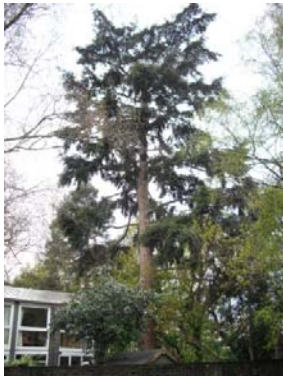
Douglas Fir T6:

This tree is a healthy mature Douglas Fir which exhibits no features of particular concern from a health and safety perspective.

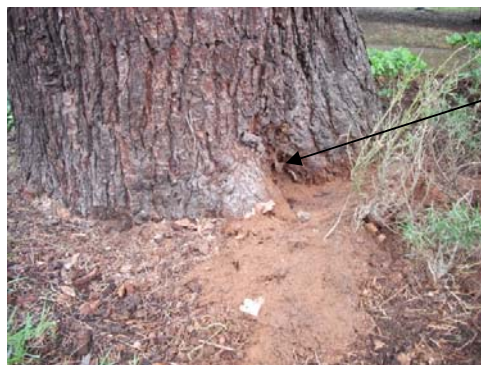
There is an open cavity at the base of the tree on the southern side, with an aperture diameter of approximately 10cm. This was probed with a steel probe to a depth of over 45cm.

Open cavity at base on southern side – probed to 45cm+

6.5 In terms of timescales, it is recommended that Cedar T7 be removed immediately/ as soon as possible (Priority 1). It is further recommended that the remaining trees be fully assessed again by a suitably qualified and experienced arboricultural consultant in two year's time (from the date of this report) or after extreme weather events/reports of tree failure or features of concern.

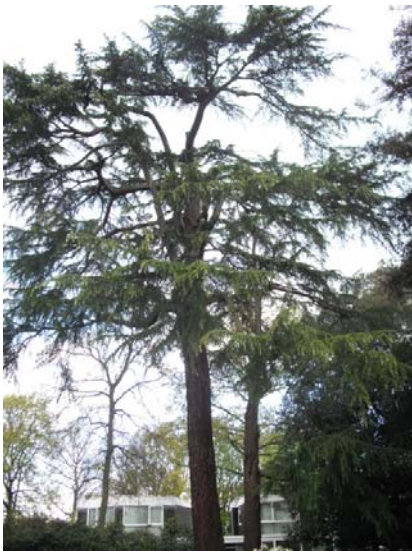
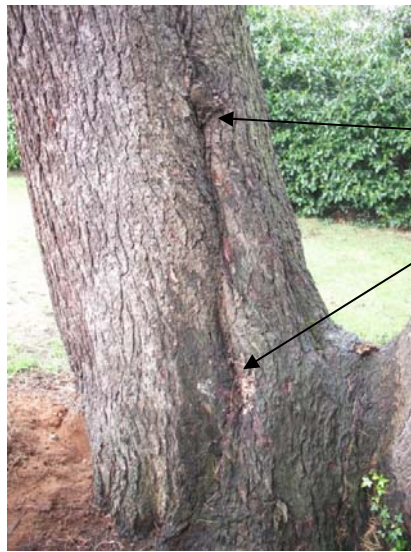
There are the remnants of fungal sporophores (fruiting bodies) on the main stem at heights of 0.5 and 1.5m on the eastern side. The sporophores were too degraded for the fungus to be identified with certainty on site.

Remnants of fungal sporophores on main stem (east side) at heights of 0.5 and 1.5m

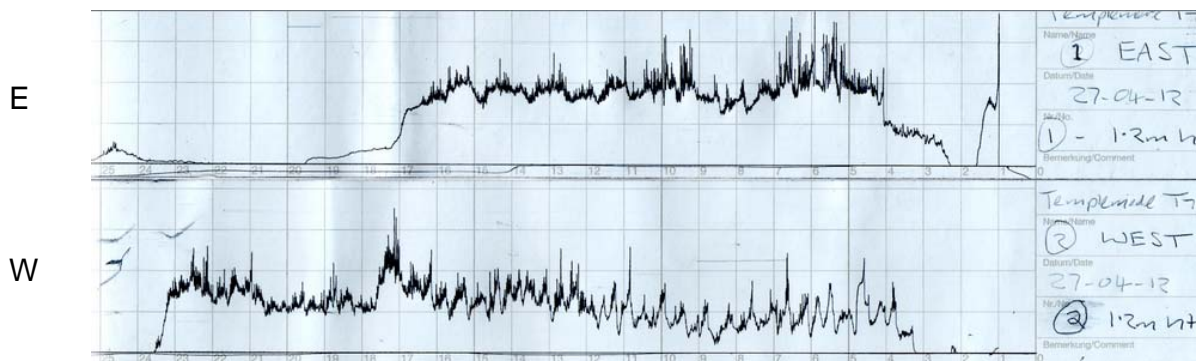
Two Resistograph drillings were undertaken in the main stem at a height of 1.2m on the eastern and western sides (one on the side of the sporophores and one on the opposite side). The resulting traces are as follows:

The traces show that the depth of sound wood on the eastern side of the main stem at a height of 1.2m is 16cm and that the depth of sound wood on the western side is 23cm. Given that the stem diameter at the height of drilling is 90cm, an illustration of the likely pattern and extent of the decayed area is shown below:

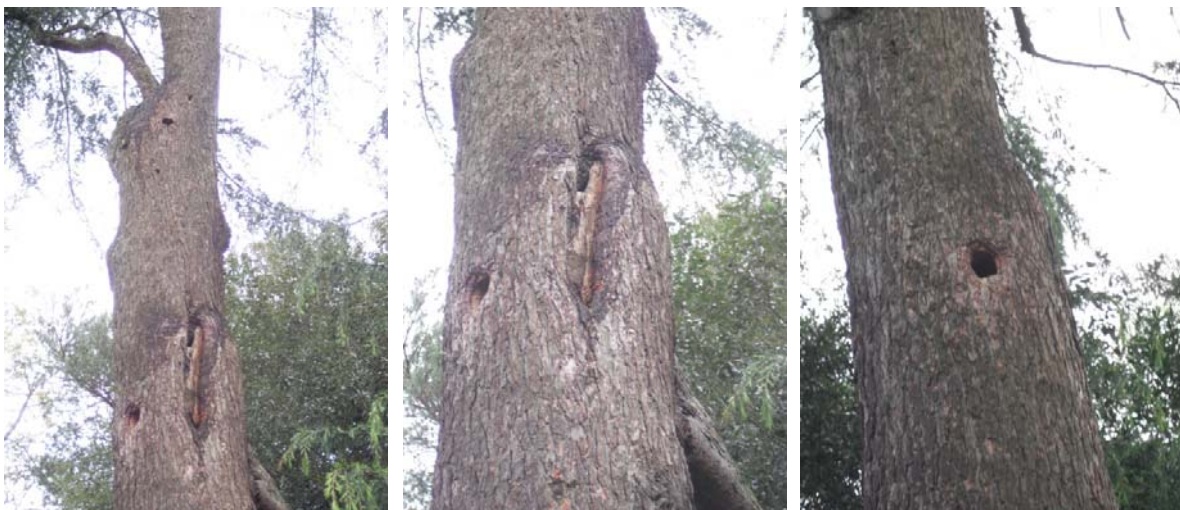
In addition to the cavity at the base of the main stem and the area of decay in the lower stem, there are Woodpecker holes in the subsidiary stem at a height of 6m on the south-western side and 9m on the southern side. There is an area of decay associated with the hole at 6m height.

Subsidiary stem of T7 showing Woodpecker holes and areas of decay
