**Arboricultural Report:**

*Cintra, Pyrford Heath, Woking GU22 8SR*

APA/AP/2025/015

28<sup>th</sup> January 2025

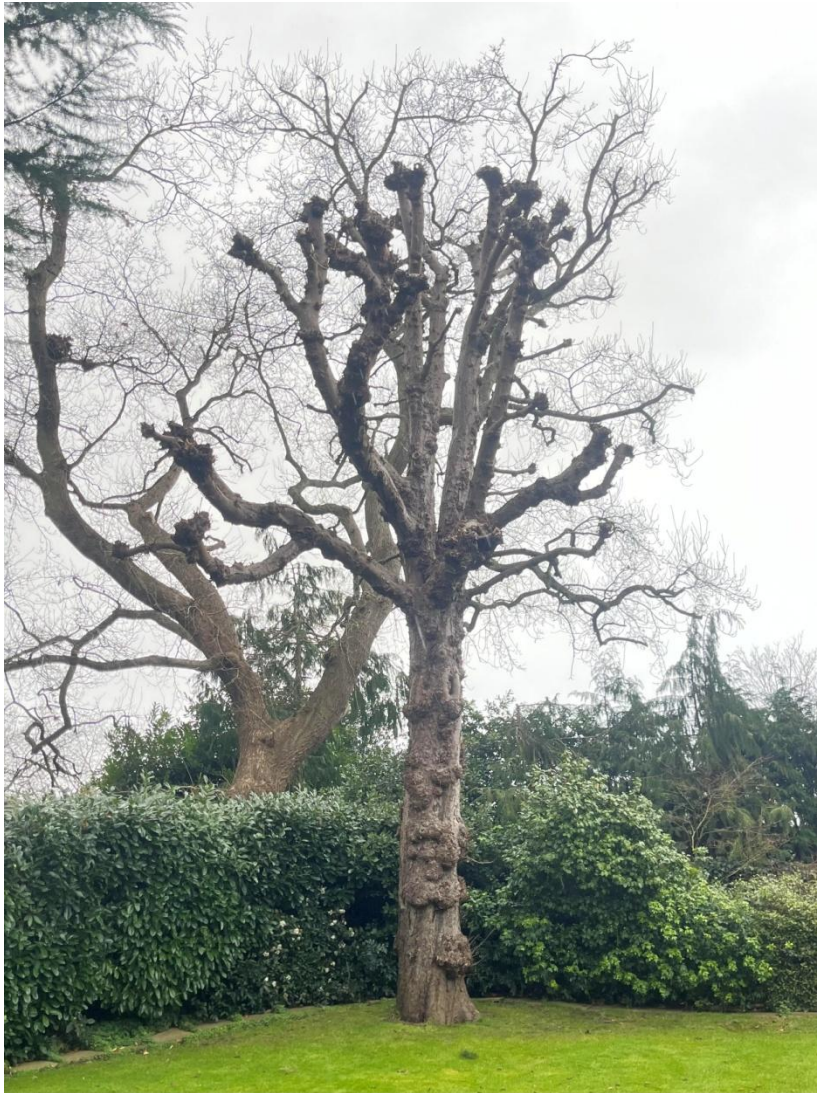
**View of tree from south-east:**

- 5.3 The tree appears to be of essentially normal vigour, although this is difficult to assess with accuracy with the tree not being in leaf and having been re-pollarded relatively recently.

- 6.1 On balance, the recommendation is to remove the tree as soon as possible. Whilst it could be retained in the short term (potentially with some pruning works to reduce the likelihood of failure) it would have a limited life expectancy and removal and replacement with a new tree is considered to constitute the most sensible course of action.
- 6.2 It is further recommended that the stump be removed/ground out. This will help prevent the fungus spreading to other adjacent trees (including the Oak to the north-west).
- 6.3 As the tree is protected removal will require the consent of the Council (either by way of a tree-works application or confirmation that it may be removed under an exception to the usual requirements of the legislation).

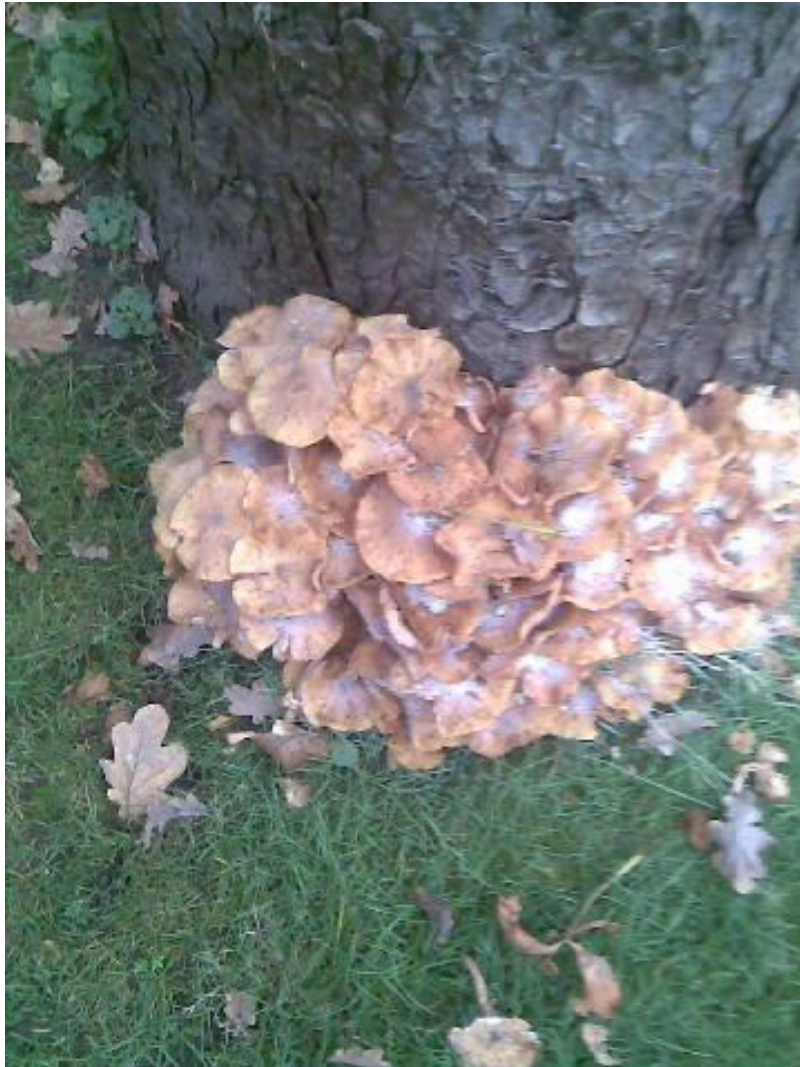
- 5.4 There are no sporophores at the base of the tree at the present time and there is no indication of root plate movement or heave.
- 5.5 The owner of the tree noted sporophores at two separate locations at the base of the tree in December 2024 and further sporophores emanating from the roots approximately 2m from the stem base.
- 5.6 Upon examination of the photographs it appears likely that the fungus in question is Honey Fungus. This is also consistent with the recent failure of an adjacent tree and that the tree sounds hollow on the southern side upon use of a sounding hammer.
- 5.7 Honey fungus is known to affect the structural roots of trees and render them liable to wind-throw (being blown over in high winds).

**Fungus noted at base of tree on southern side in December 2024:**

- 5.8 As the tree has been re-pollarded and is not currently in leaf the risk of it failing at the present time is considered to be relatively low.
- 5.9 The tree is likely, however, to have a limited safe life expectancy and if it were to be retained it would be difficult to assess the extent to which structural roots and the integrity of the lower stem may have been compromised.
